From Tufte, Edward. *Visual Explanations: Images and Quantities, Evidence and Narrative*. Cheshire, CT: Graphics P, 1997.

The Decision to Launch the Space Shuttle Challenger

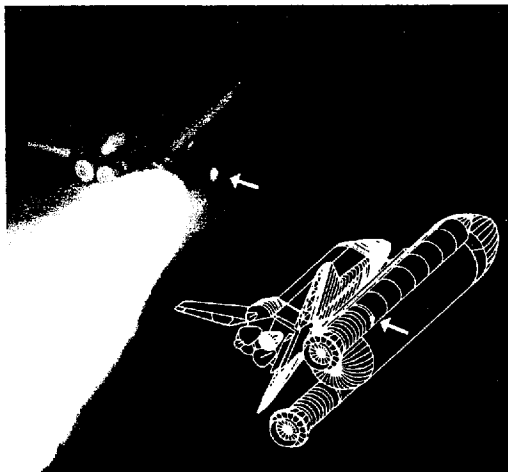
On the launch pad, the leak lasted only about 2 seconds and then apparently was plugged by putty and insulation as the shuttle rose, flying through rather strong cross-winds. Then 58.788 seconds after ignition, when the Challenger was 6 miles up, a flicker of flame emerged from the leaky joint. Within seconds, the flame grew and engulfed the fuel tank (containing liquid hydrogen and liquid oxygen). That tank ruptured and exploded, destroying the shuttle.

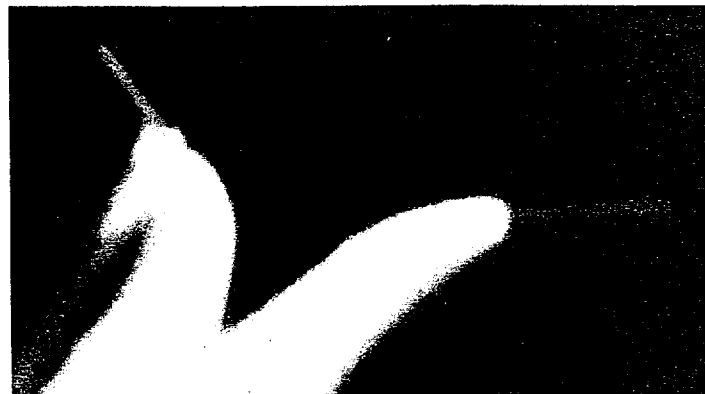
As the shuttle exploded and broke up at approximately 73 seconds after launch, the two booster rockets crisscrossed and continued flying wildly. The right booster, identifiable by its failure plume, is now to the left of its non-defective counterpart.

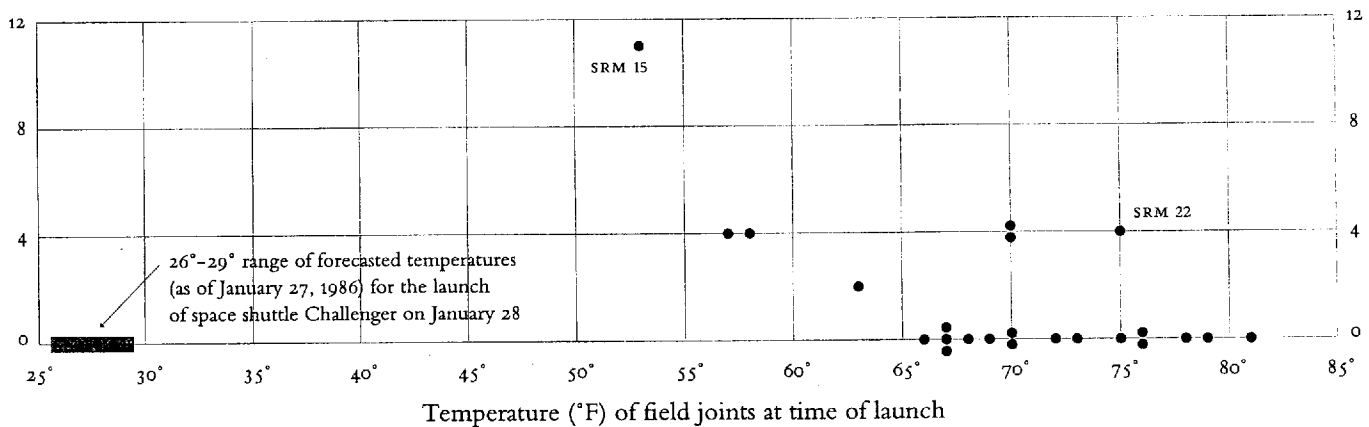
O-ring damage
index, each launch

Above, a scatterplot shows the experience of all 24 launches prior to the Challenger. Like the table, the graph reveals the serious risks of a launch at 29°. Over the years, the O-rings had persistent problems at cooler temperatures: indeed, *every* launch below 66° resulted in damaged O-rings; on warmer days, only a few flights had erosion. In this graph, the temperature scale extends down to 29°, visually expressing the stupendous extrapolation beyond all previous experience that must be made in order to launch at 29°. The coolest flight without any O-ring damage was at 66°, some 37° warmer than predicted for the Challenger; the forecast of 29° is 5.7 standard deviations distant from the average temperature for previous launches. This launch was completely outside the engineering database accumulated in 24 previous flights.

This data matrix shows the complete history of temperature and O-ring condition for all previous launches. Entries are ordered by the possible cause, temperature, from coolest to warmest launch. Data in red were exhibited at some point in the 13 pre-launch charts; and the data shown in black were not included. I have calculated an overall O-ring damage score for each launch.³⁶ The table reveals the link between O-ring distress and cool weather, with a concentration of problems on cool days compared with warm days:

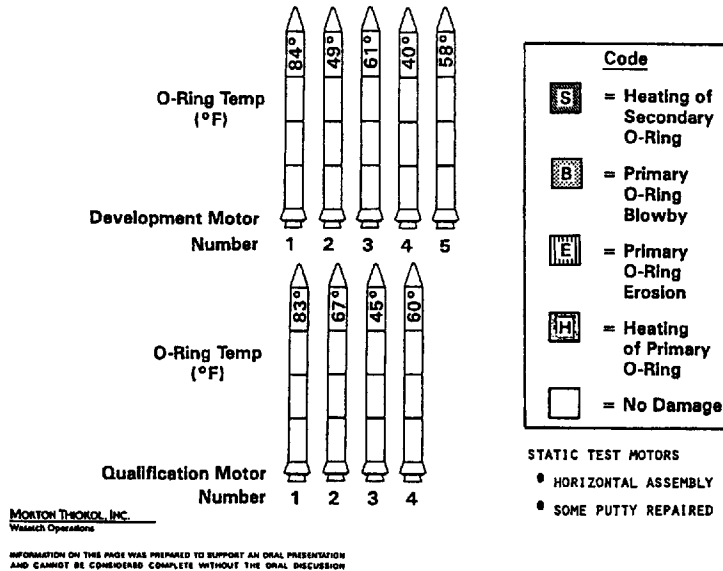
History of O-Ring Damage in Field Joints

Prepared for testimony to the commission, the chart above shows nine little rockets annotated with temperature readings turned sideways. A legend shows a damage scale. Apparently measured in orderly steps, this scale starts with the most serious problem (“Heating of Secondary O-ring,” which means a primary ring burned through and leaked) and then continues in several ordered steps to “No Damage.” Regrettably, the scale's visual representation is disordered: the cross-hatching varies erratically from dark, to light, to medium dark, to darker, to lightest—a visual pattern unrelated to the substantive order of the measured scale. A letter-code accompanies the cross-hatching. Such codes can hinder visual understanding.

At any rate, these nine rockets suffered no damage, even at quite cool temperatures. But the graph is not on point, for it is based on test data from “Development and Qualification Motors”—all fixed rockets ignited on horizontal test stands at Thiokol, never undergoing the stress of a real flight. Thus this evidence, although perhaps better than nothing (that's all it is better than), is not directly relevant to evaluating the dangers of a cold-weather launch. Some of these same temperature numbers for test rockets are found in a pre-launch chart that we saw earlier.

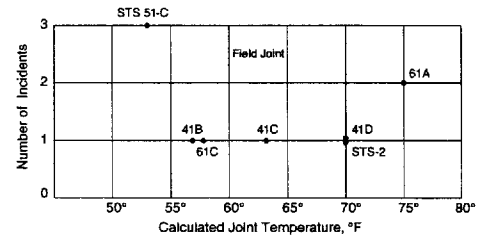
³⁹ Most accounts of the Challenger re-produce a scatterplot that apparently demonstrates the analytical failure of the pre-launch debate. This graph depicts only launches with O-ring damage and their temperatures, omitting all damage-free launches (an absence of data points on the line of zero incidents of damage):

First published in the shuttle commission report (PCSSCA, volume 1, p. 146), the chart is a favorite of statistics teachers. It appears in textbooks on engineering, graphics, and statistics—relying on Dalal, Fowlkes, Hoadley, “Risk Analysis of the Space Shuttle: Pre-Challenger Prediction of Failure,” who describe the scatterplot as having a central role in the launch decision. (The commission report does not say when the plot was made.) The graph of the missing data-points is a vivid and poignant object lesson in how not to look at data when making an important decision. But it is too good to be true! First, the graph was *not* part of the pre-launch debate; it was *not* among the 13 charts used by Thiokol and NASA in deciding to launch. Rather, it was drawn *after* the accident by two staff members (the executive director and a lawyer) at the commission *as their simulation* of the poor reasoning in the pre-launch debate. Second, the graph implies that the pre-launch analysis examined 7 launches at 7 temperatures with 7 damage measurements. That is not true; only 2 cases of blow-by and 2 temperatures were linked up. The actual pre-launch analysis was much thinner than indicated by the commission scatterplot. Third, the damage scale is dequantified, only counting the number of incidents rather than measuring their severity. In short, whether for teaching statistics or for seeking to understand the practice of data graphics, why use an inaccurately simulated post-launch chart when we have the genuine 13 pre-launch decision charts right in hand? (On this scatterplot, see Lighthall, “Launching the Space Shuttle Challenger;” and Vaughan, *Challenger Launch Decision*, pp. 382–384.)

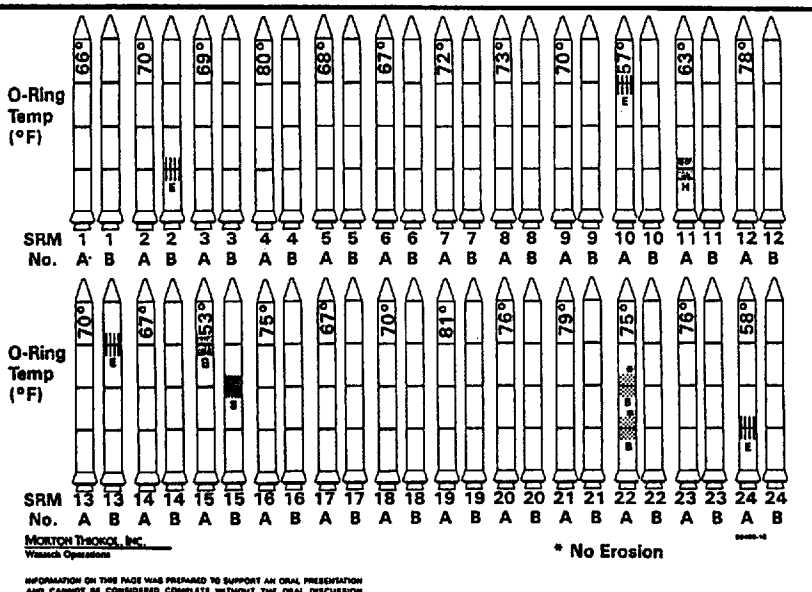
History of O-Ring Damage in Field Joints (Cont)

The second chart in the sequence is most significant. Shown below are the O-ring experiences of all 24 previous shuttle launches, with 48 little rockets representing the 24 flight-pairs:

Rockets marked with the damage code show the seven flights with O-ring problems. Launch temperature is given for each pair of rockets. Like the data matrix we saw earlier, this display contains *all* the information necessary to diagnose the relationship between temperature and damage, if we could only see it.⁴¹ The poor design makes it impossible to learn what was going on. In particular:

The Disappearing Legend At the hearings, these charts were presented by means of the dreaded overhead projector, which shows one image after another like a slide projector, making it difficult to compare and link images. When the first chart (the nine little rockets) goes away, the visual code calibrating O-ring damage also vanishes. Thus viewers need to memorize the code in order to assess the severity and type of damage sustained by each rocket in the 48-rocket chart.

⁴¹ This chart shows the rocket pair SRM 4A, SRM 4B at 80°F, as having *undamaged* O-rings. In fact, those rocket casings were lost at sea and their O-ring history is unknown.

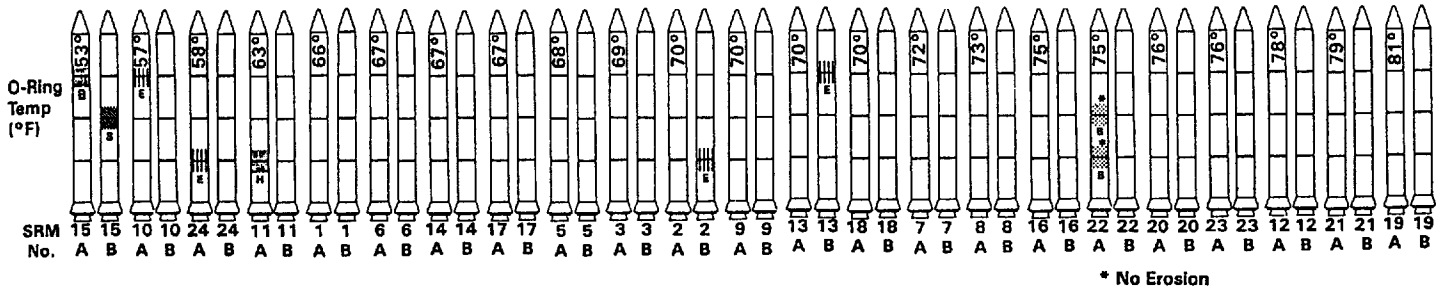
Information displays should serve the analytic purpose at hand; if the substantive matter is a possible cause-effect relationship, then graphs should organize data so as to illuminate such a link. Not a complicated idea, but a profound one. Thus the little rockets must be *placed in order by temperature, the possible cause*. Above, the rockets are so ordered by temperature. This clearly shows the serious risks of a cold launch, for most O-ring damage occurs at cooler temperatures. Given this evidence, how could the Challenger be launched at 29°?

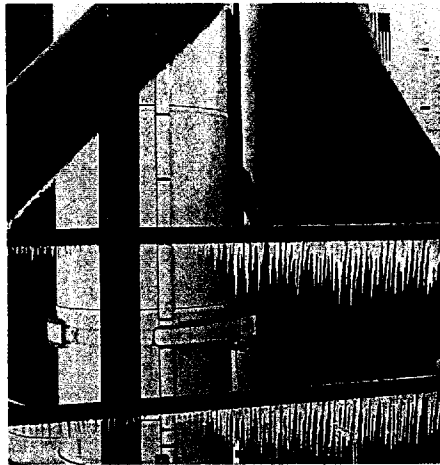
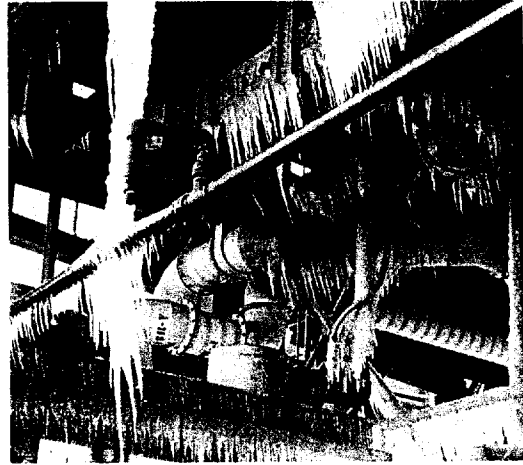
To create a more effective exhibit, the clamped O-ring might well have been placed in a transparent glass of ice water rather than in the opaque cup provided to Feynman. Such a display would then make a visual reference to the extraordinary pre-flight photographs of an ice-covered launch pad, thereby tightening up the link between the ice-water experiment and the Challenger.⁴⁵

⁴⁵ Above, icicles hang from the service structure for the Challenger. At left, the photograph shows icicles near the solid-fuel booster rocket; for a sense of scale, note that the white booster rocket is 12 ft (3.7 m) in diameter. From PCSSCA, volume I, p. 113. One observer described the launch service tower as looking like “. . . something out of Dr. Zhivago. There’s sheets of icicles hanging everywhere.” House Committee on Science and Technology, *Investigation of the Challenger Accident*, p. 238. Illustration of O-ring experiment by Weilin Wu and Edward Tufte.
